AEDC-TR-77-37

**VIBRATION TESTING OF THIOKOL CHEMICAL CORPORATION
FLTSATCOM APOGEE KICK MOTOR TE-M-364-19
(SYSTEM S/N 19006 Q-2)**

**VON KARMAN GAS DYNAMICS FACILITY
ARNOLD ENGINEERING DEVELOPMENT CENTER
AIR FORCE SYSTEMS COMMAND
ARNOLD AIR FORCE STATION, TENNESSEE 37389**

Final Report for Period 5 - 17 January 1977

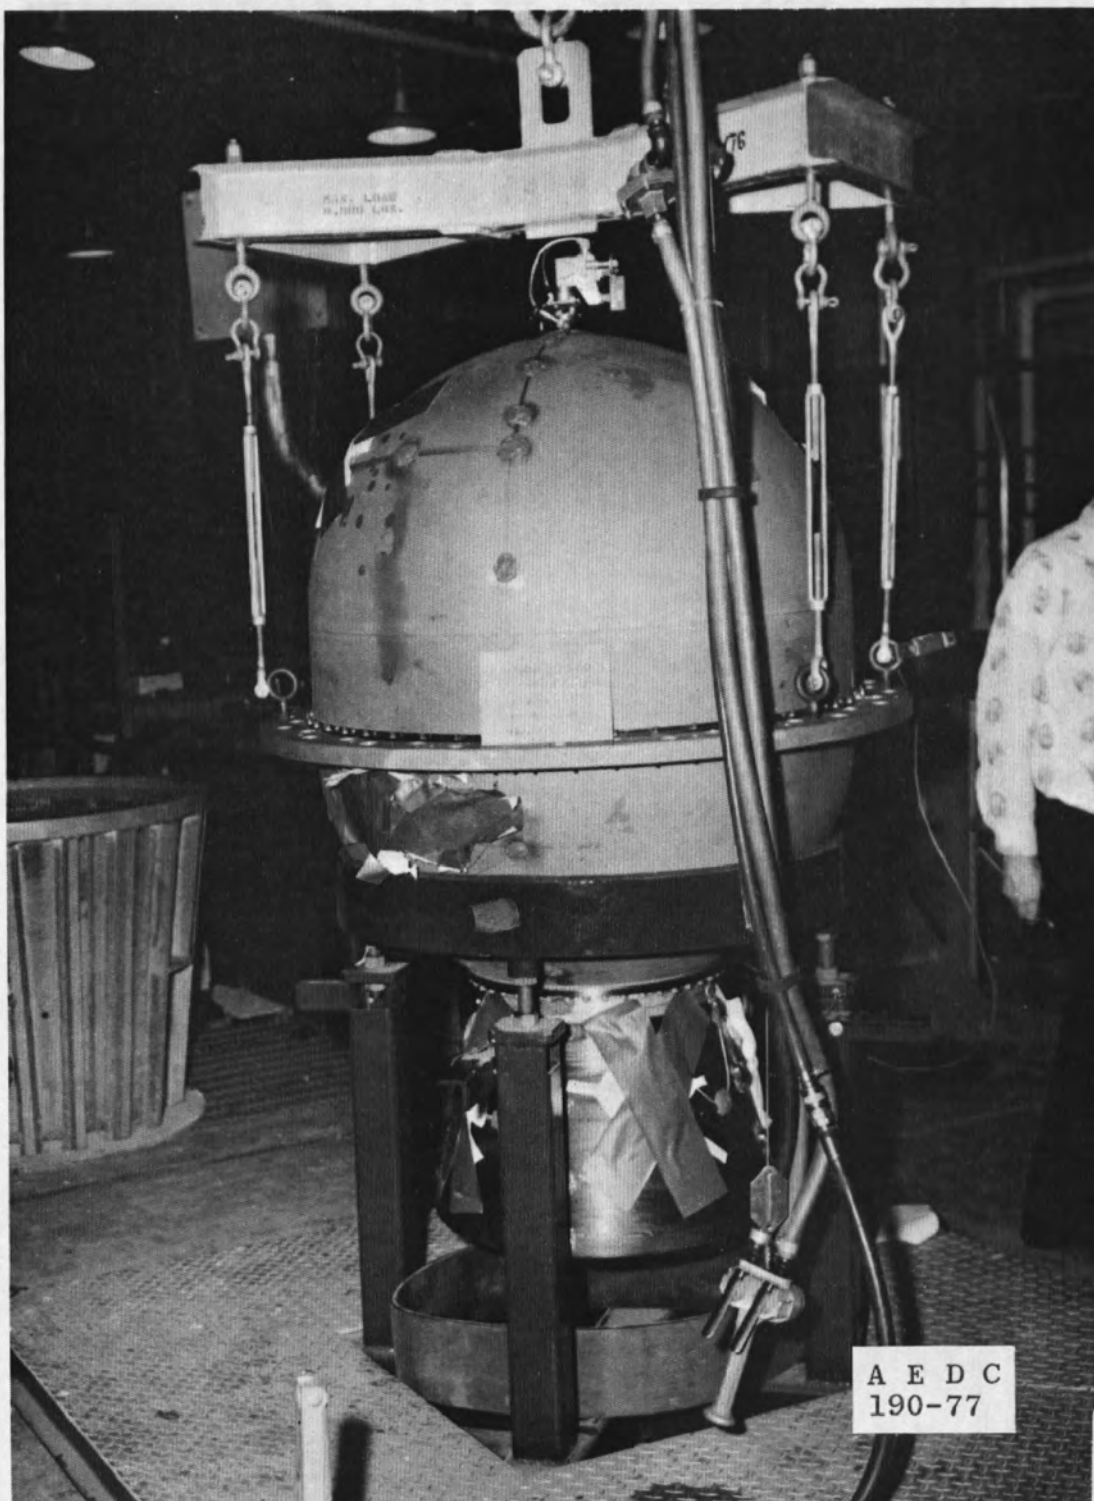
b. Support stand
Figure 2. Continued.

Test article handling is accomplished by use of the IVA mobile crane in conjunction with special handling and support fixtures provided by the test article manufacturer or AEDC (Fig. 2).

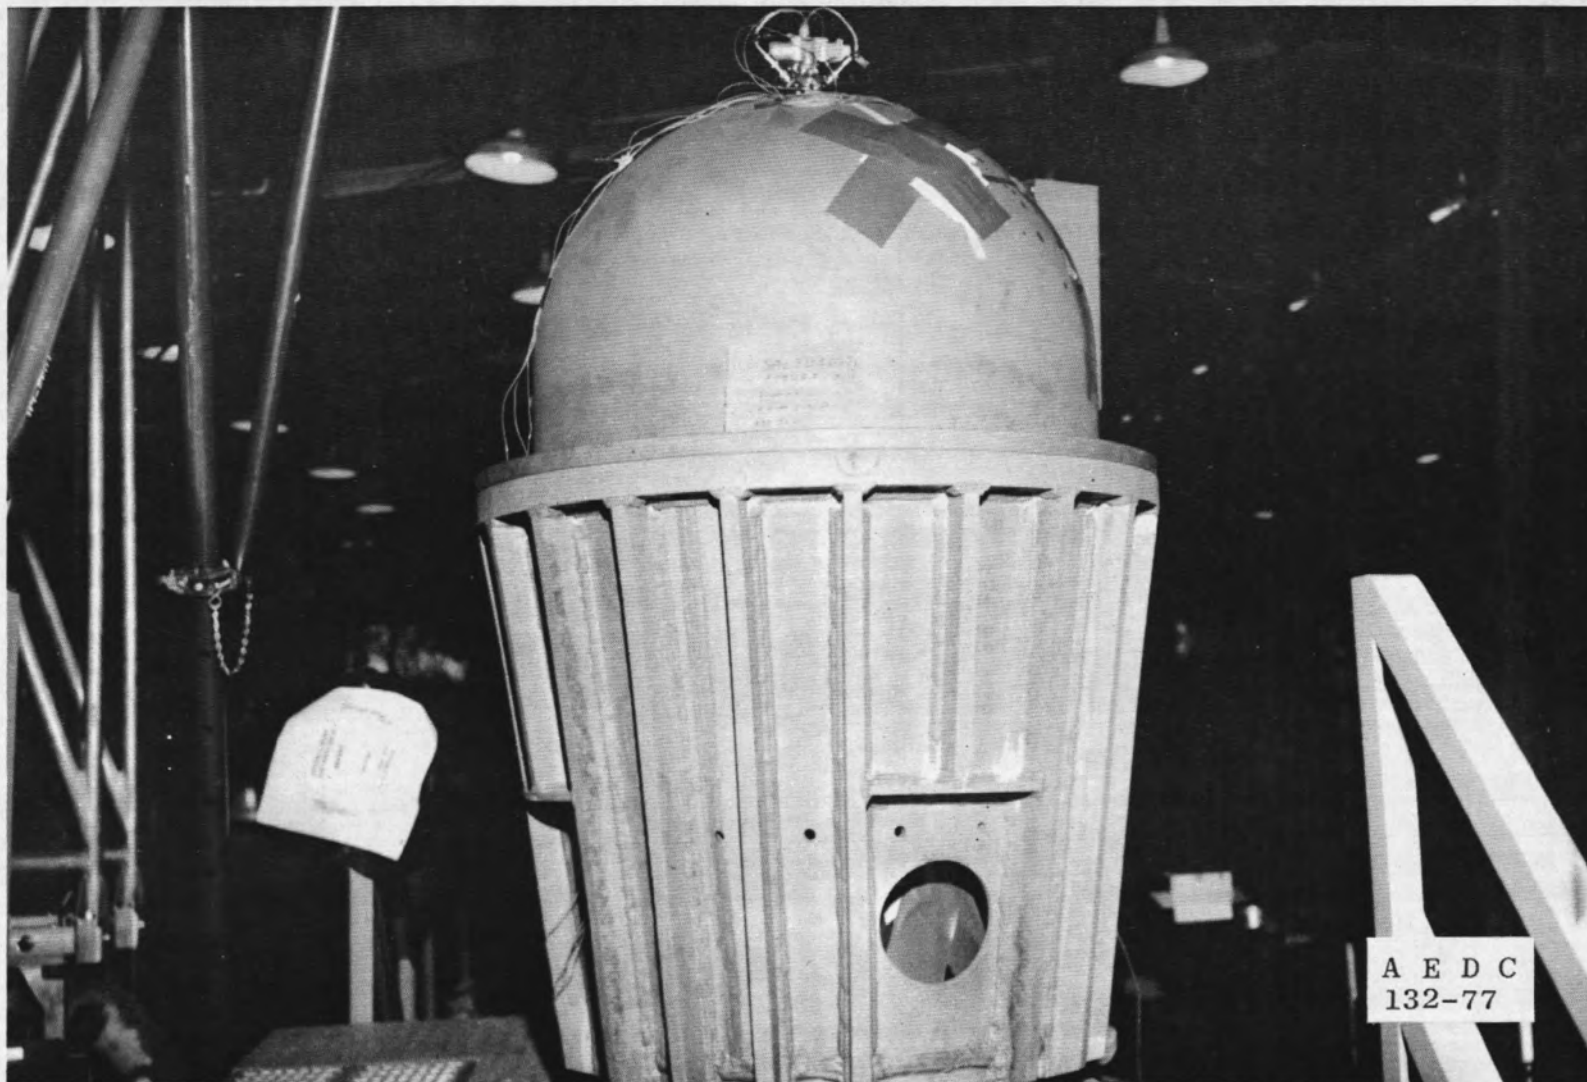
b. Thrust axis
Figure 6. Continued.

from the transportation fixture, instrumented, and installed in the dynamics test fixture (Figs. 6a and b). Testing of the motor was initiated January 10 and completed January 14, 1977. All testing of the FLTSATCOM motor was conducted with expended initiators installed in the ignition train and the S&A device in the safe position. During the test period, the temperature of the IVA test unit building was maintained in the range from 65 to 75°F except for January 9 and 10 when, due to low outside temperatures, the building temperature ranged from 50 to 60°F. At the conclusion of testing, the motor was placed in the transportation fixture and transported to the AEDC Radiographic Inspection Laboratory for postvibration inspection prior to motor firing in the AEDC Engine Test Facility (ETF) Propulsion Development Test Cell T-3. A summary of the system dynamic test activities and building temperature record is contained in Table 2.
